GRETLEY MINE DISASTER

Allan Clapham

Training Officer – Newcastle Mines Rescue Station

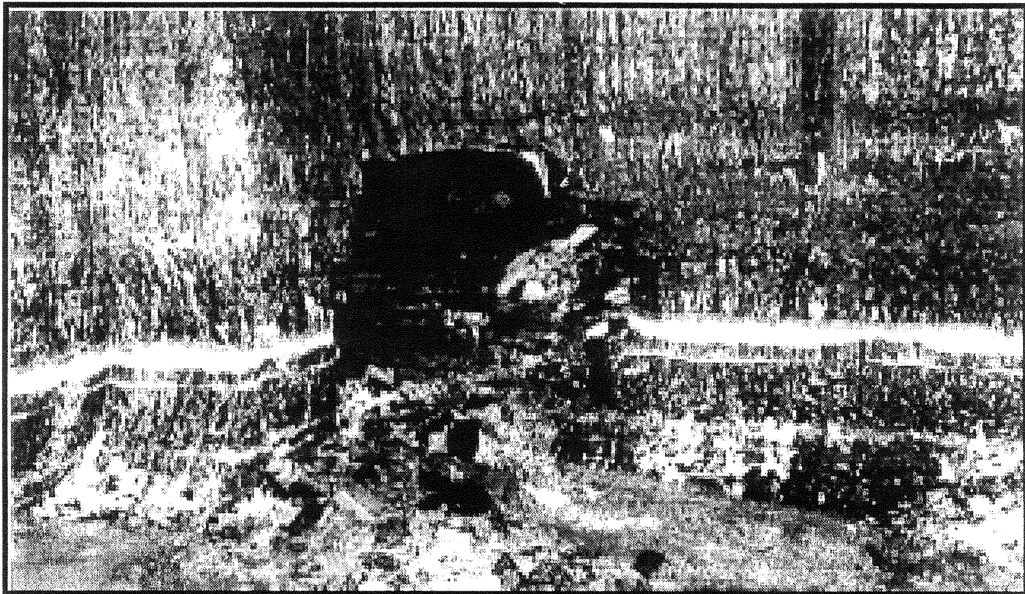
Figure 1 – 1 meter x 1 meter hole into old workings

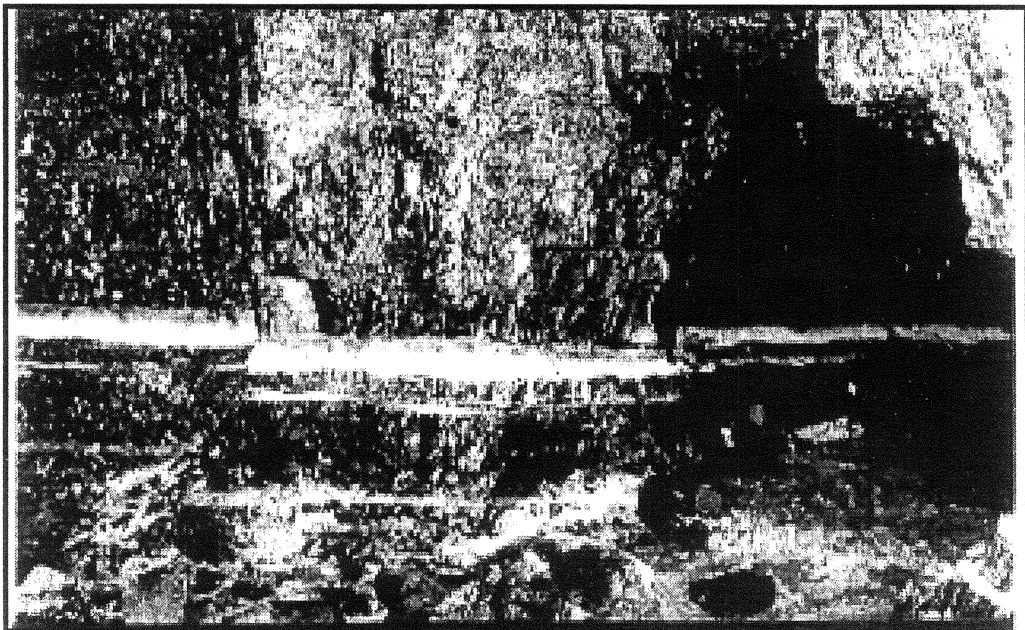
Figure 2 - Close up of holing

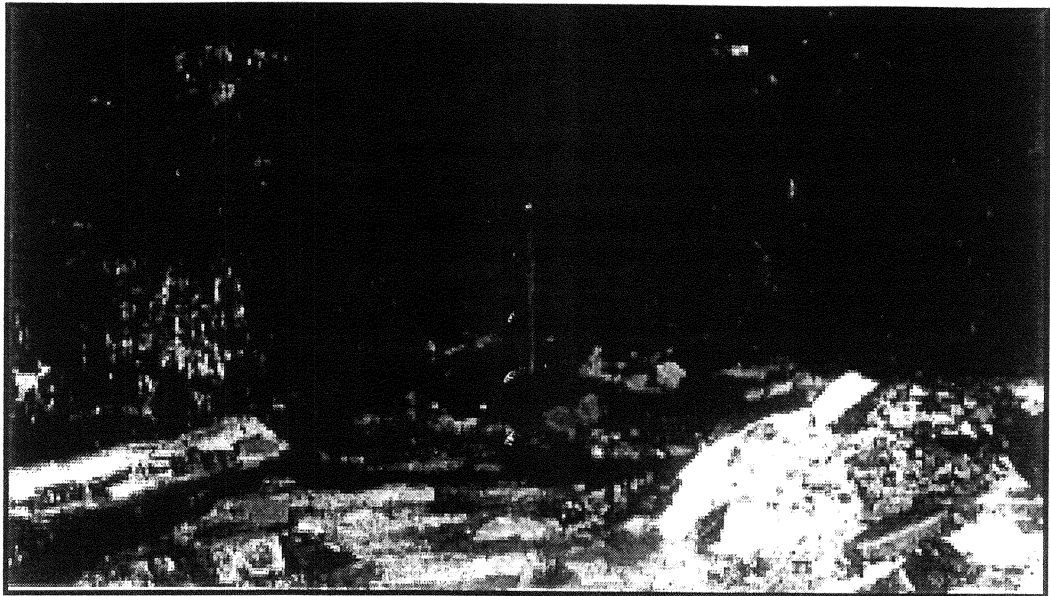
Figure 3 - A view into the old Workings

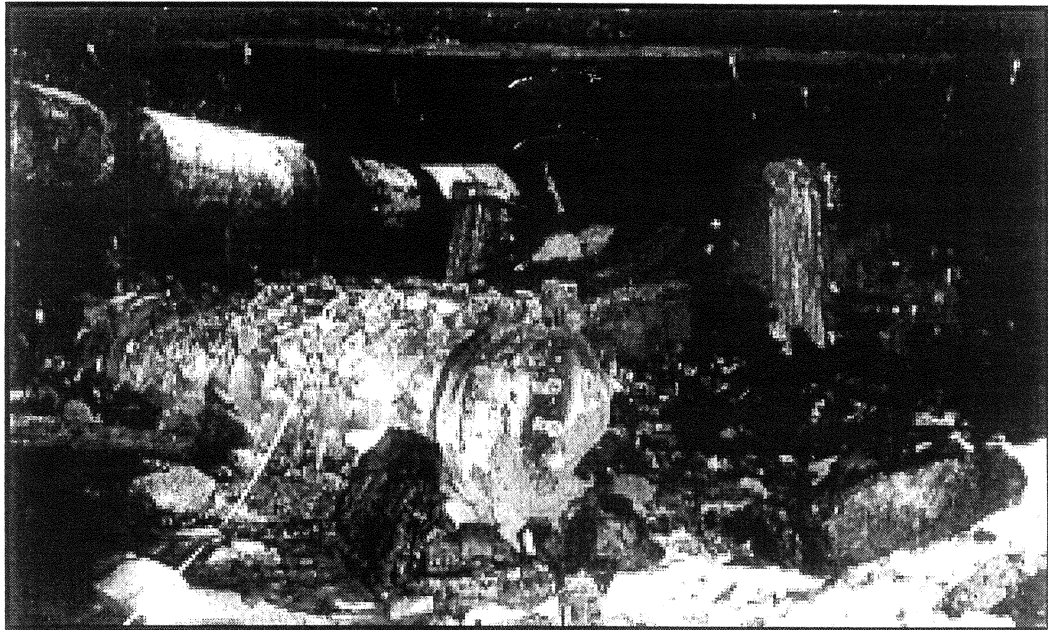
Suddenly, with tremendous force, water rushed into the heading from a hole in the face made by the continuous miner. That machine, weighing between 35 and 50 tonnes, was swept some 17.5 metres back down the heading where it jammed against the sides. The four men were engulfed by the water, swept away and drowned. The remaining team members survived the disaster by reason of being in the crib room, which itself was flooded.

Figure 4 - Miner pushed 15 meters back from holing point

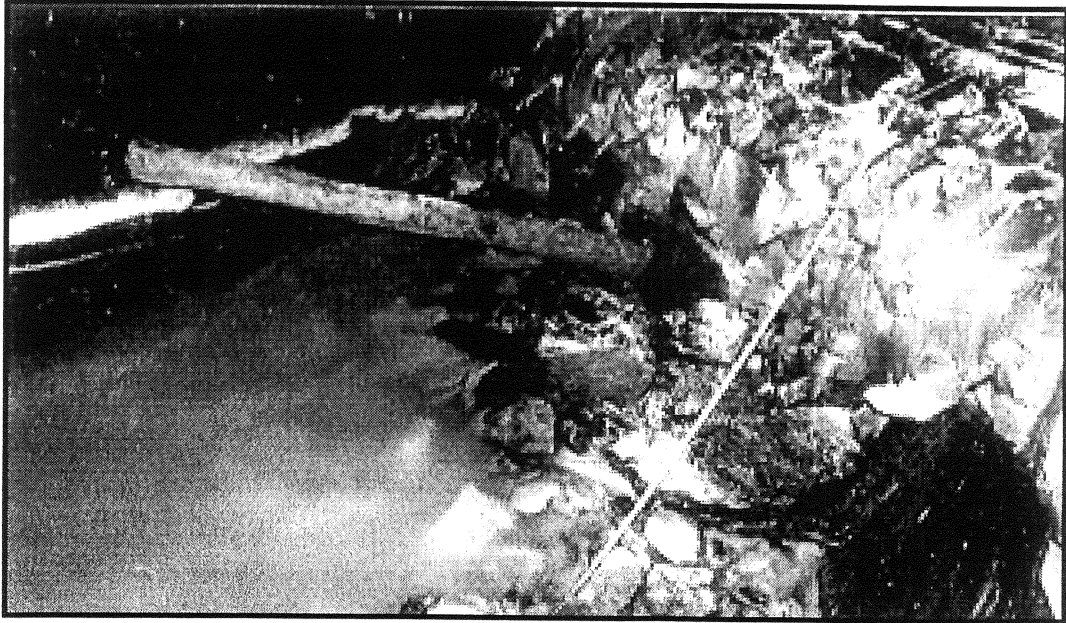
Figure 5 - Debris jammed into head of Miner

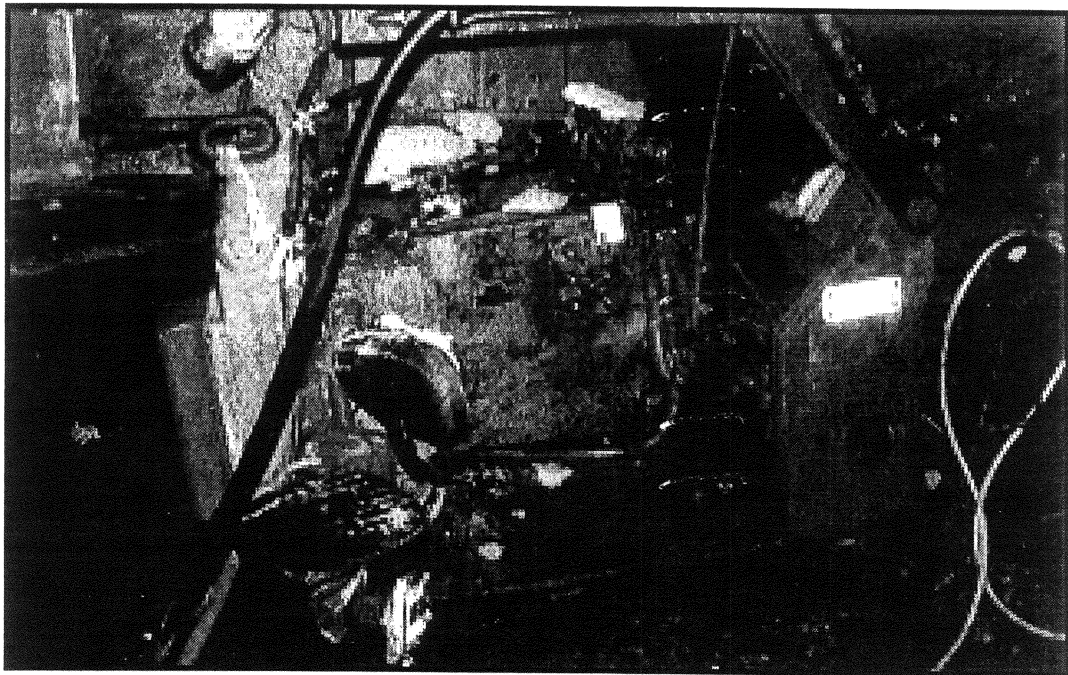
Figure 6 - Miner 'Water Blasted' clean - Note position of seat

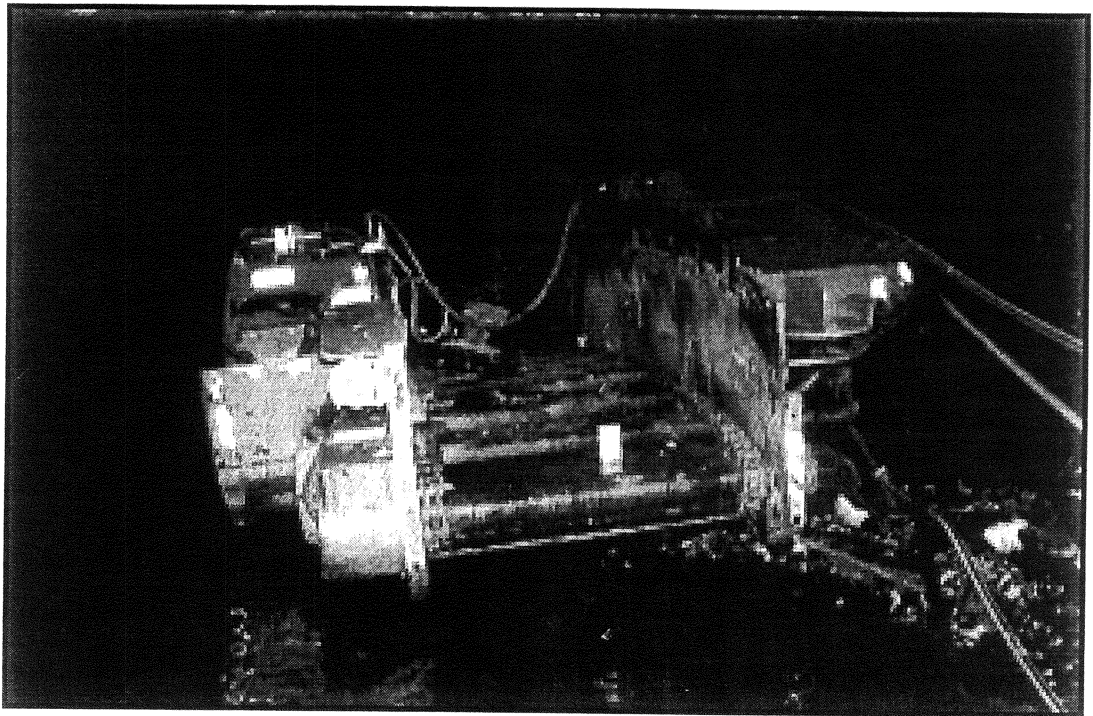
Figure 7 - Shuttle Car (which was full of coal) is water blasted clean

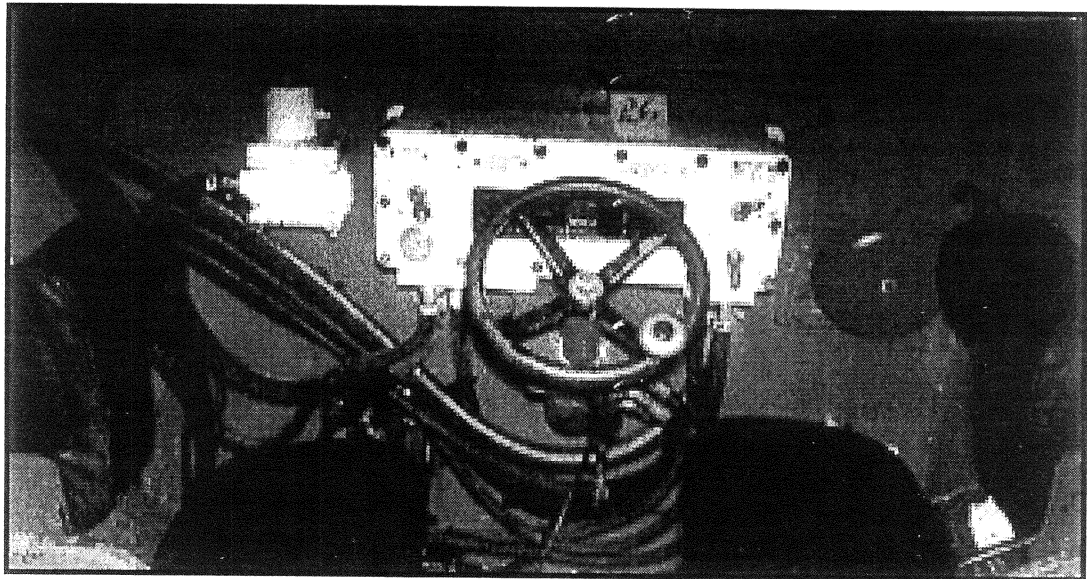
Figure 8 - Shuttle Car control panel - water blasted clean.
