## 2<sup>nd</sup> International Mines Rescue Conference 2005

### Emerging Mine Inertisation Philosophy carried out in the United States of America

***Ian Houlison,  
Dave Hussey,  
George Watson,  
Patti L. Meyer,***

### **Glassport, Pennsylvania USA**

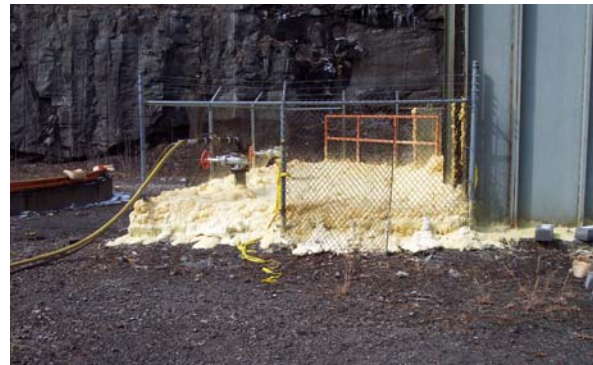
**Mine portal seal utilizing PUR  
Note: Yellow Nitrogen hose**

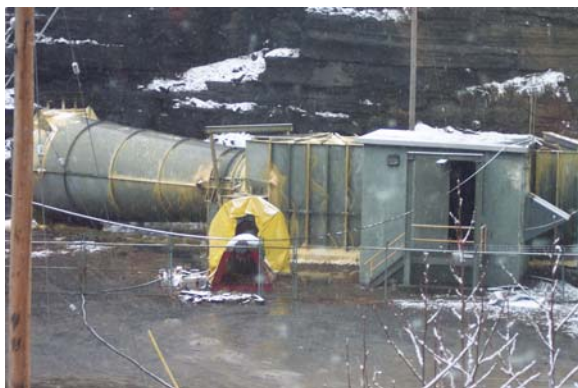
**No. 4 Return side**

1. Instruction was given to heat the PUR to the required temperature in preparation for application at the seal site.
2. The first task was back at No. 4 shaft where a recoat of a few places was in order, and then a coating of the explosion doors that had a light Foam Pak PUR. The light 1.75 lb. density foam was not holding under pressure. After the RokLok PUR was applied there appeared to be no further problem.

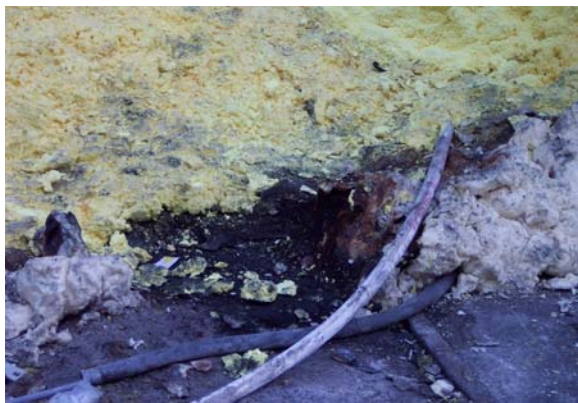
The day was utilized resealing particularly No. 8 shaft with RokLok 70 to seal material applied by another PUR company that had reacted poorly.

**Observed poor application at No 8**

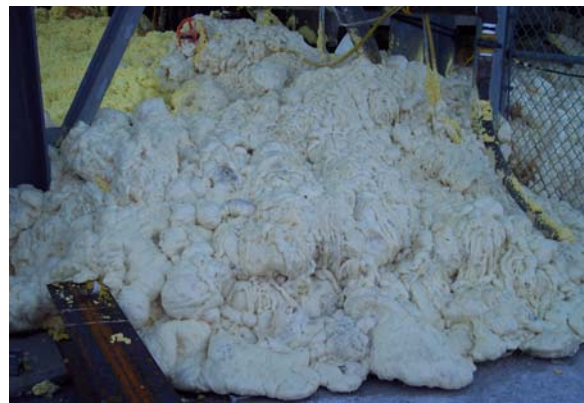
**Material applied at southern side**

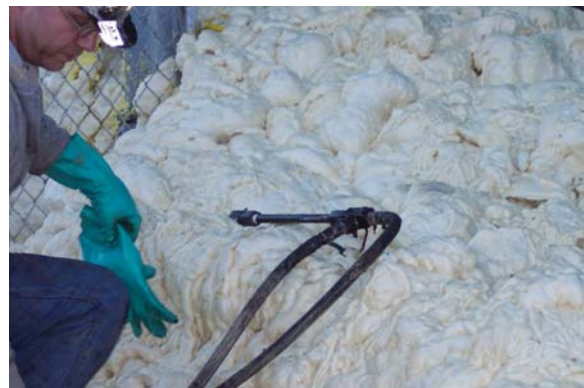
**Close inspection prior to sealing**

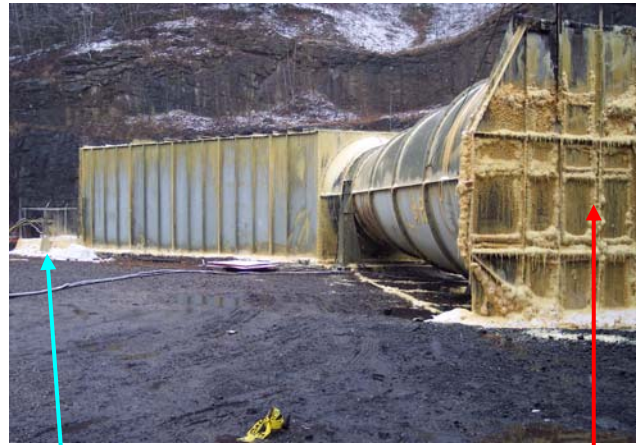
**RokLok 70 coating at No. 2  
Intake & Return**

1. No. 4 Shaft applied coat of RokLok 70.
2. No. 4 Vent shaft waited and added a coat of foam.
3. Service shaft was given a complete coat of foam as instructed.
4. No. 2 Shaft applied coat of RokLok 70.
5. No. 2 Vent shaft waited and added a coat of foam as instructed.

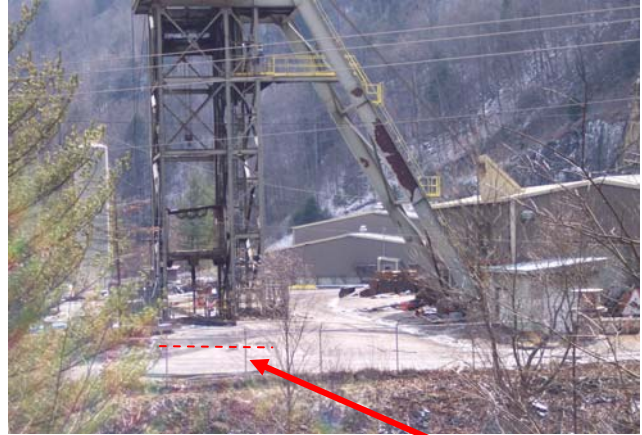
**Service Shaft (approximate seal level)**

1. Started at No. 1 shaft to also put a coat of RokLok 70 as instructed.
2. Touched up leaks on Service Shaft found earlier in the morning by the Mines Rescue Team during routine inspections when the shaft was at positive pressure.
3. Went back to Vent 8 once again to touch up leaks again detected by the Mines Rescue Team during routine inspections when the shaft was at positive pressure early in the morning.

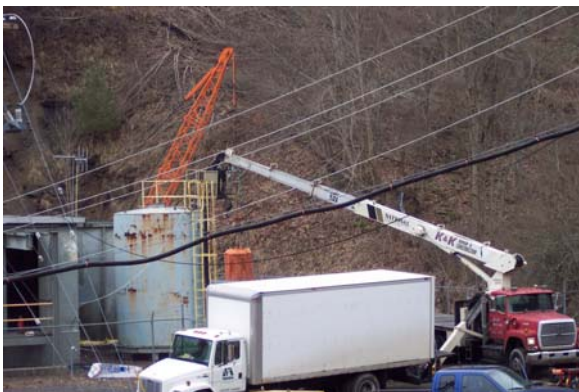
**No. 4 Shaft aerial foam application**

1. Went to No. 4 Shaft and fixed up leaks around fan housing.
2. **Lanced around the base of the intake shaft.**
3. Fixed up small leaks on production shaft on the flat surface.
4. Went back to No. 1 Ventilation shaft; fixed up leaks.
5. **Started to lance around base.**
6. **Went back to No. 7 Ventilation shaft and lanced around the base where leaks had been detected earlier.**

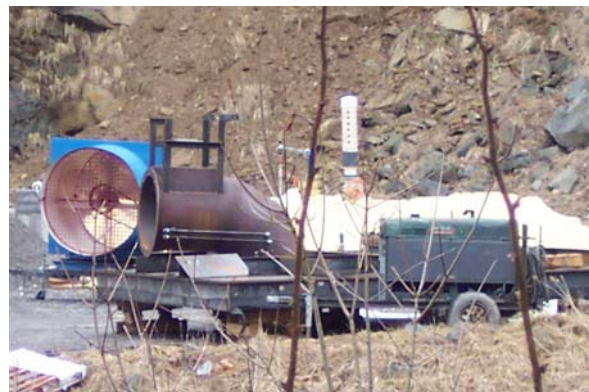
**No. 7 Shaft with pressure relief fitted**

As an added feature pressure relief devices were fitted to all seals to guard against over pressure damage and reduce the amount of repairs required. These relief units were self closing as the pressure dropped to prevent ingress of oxygen.

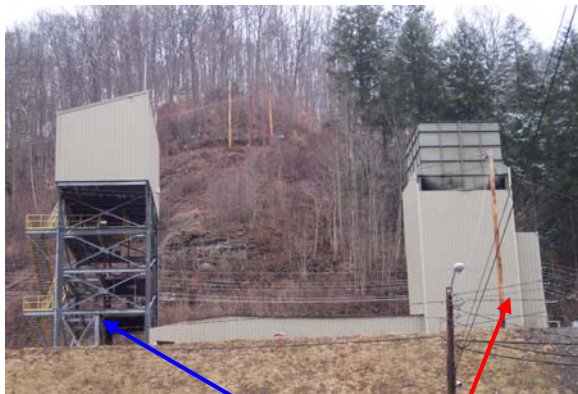
**No. 8 Shaft Intake & Return**

1. Advised to return and finish lance job on No. 1 Ventilation Shaft.
2. Went back to No. 7 Ventilation Shaft and repaired leak at base.
3. No. 8 Ventilation Shaft required some additional work.  
Accompanied Mines Rescue Team as they were tasked to remove a leaking flange and replace with a new one.  
The pressure was building well at this location and any leaks were laden with high levels of Carbon Monoxide and Methane so the following tasks had to be completed utilizing the Drager BG 174 closed circuit breathing apparatus.
  - 3.1 Wall inside Return Fan Housing re-sprayed with foam.
  - 3.2 Waited 1 hour and coated foam with RokLok 70.
  - 3.3 Leaks around replacement flange.
  - 3.4 Leaks on wall next to cage.
  - 3.5 Minor leaks at ground level.

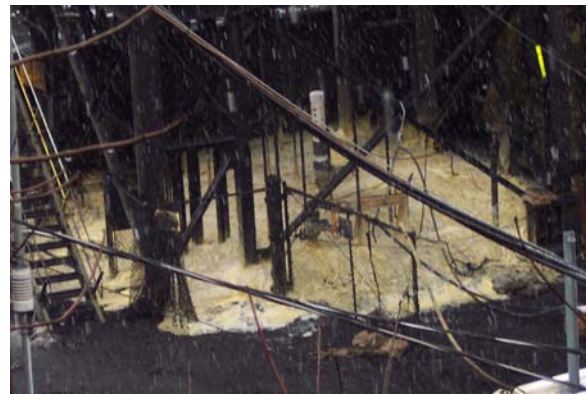
**No. 1 Intake Shaft Seal Repairs**

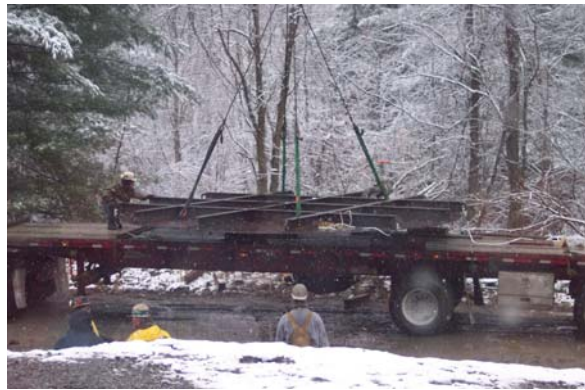
**No. 9 Return Shaft Seal Rotated**

A cap was fitted to No. 9 shaft return to take pressure off the internal MICON seal wall so it can remain intact for as long as possible or at least until removal.
