“Technical and legal aspects for rescue operation performed in harsh climate condition in Polish copper mines”

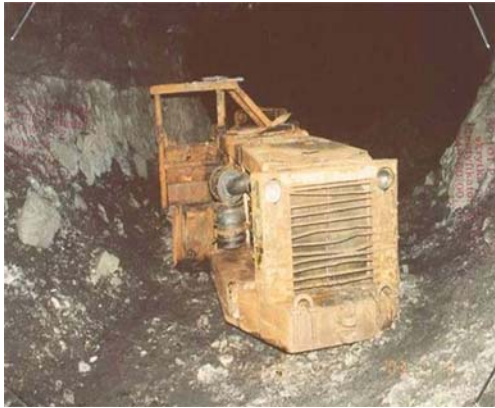
Figure 4: View of burnt LHD loader

However, due to a returning fire hazard noticed (smoke, increasing CO) precautionary action of cooling the fire site and associated machinery with water took place until 6:00 the following day. The emergency action was attended by nine rescue teams. Those teams penetrating the mine site did so in accordance with procedures for undertaking a rescue effort by trailing communication cable (ULR). The large number of galleries (room and pillar system of exploitation) to penetrate added significantly to the execution of the operation and showed the disadvantage and weakness of this type of communications for extensive and difficult penetration in complex underground working infrastructure. A specific problem was the disruption in communication and a return one of the rescue team to base, hence requiring trailing of the communications cable anew. It was determined that damaged infrastructure consisted of: 24 V electrical installation, parts and elements of hydraulic system, fuel lines, parts and elements of the hydraulic system, tyres. The hydraulic oil tank was empty and there was, from the bottom of the fuel tank, 300mm of diesel oil remaining. The probable cause for the blaze was an electrical short circuit within battery. It is understood that the short circuit near the starter motor led to the ignition of the cable insulation of the 24V electrical system, and the fuel/air mixture.

This occurred as a result of leaking hydraulic pipe connectors within the steering/operational equipment at the time of the operation of the diesel engine. The diesel engine fan successfully distributed the leaking oil throughout the starter motor vicinity and was also instrumental in the sudden and fast distribution of fire within the starter motor cover, thus engulfing the area in front of the operator's cabin and the cabin itself.

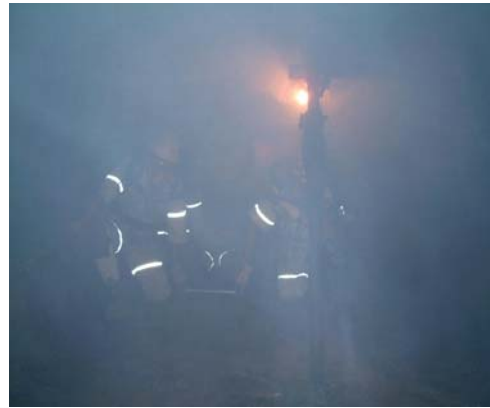
Figure 5: Visibility in light smoke

The characteristic feature of mobile equipment, belt conveyors etc. fires is a filling workings with dense smoke and total decrease of visibility. With no visibility a vital priority for rescue teams is to reduce negative results of this occurrence. The fire of LHD loader in Rudna mine has demonstrated a weakness of classic solutions (being in accordance with mining law regulations). The communication system and lack of visibility become evident clearly as the weaker links of rescue operation.

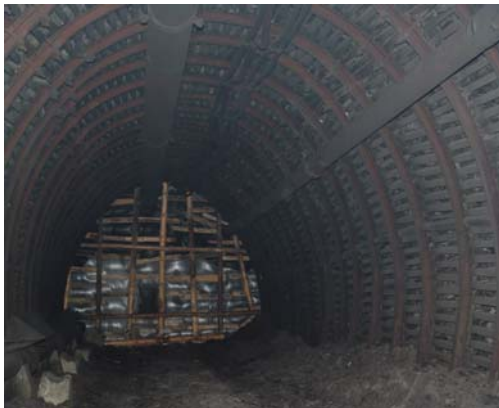
Figure 6: Temporary stopping in U-23

On the 22/12/2004 at about 02:00 it was determined that the fire was travelling through cross-cut P-9 towards drift U-25. Active fire fighting within drift U-25 was carried out from cross-cut P-10. The rescue operation depended on the limiting of air flow to the fire by use of temporary air stopping, establishing water curtains within the path of the potential spreading fire in drift U-24 and fire fighting in drift U-25. The goal of this type of action was to stop the fire from spreading in the other direction i.e. against the air current.

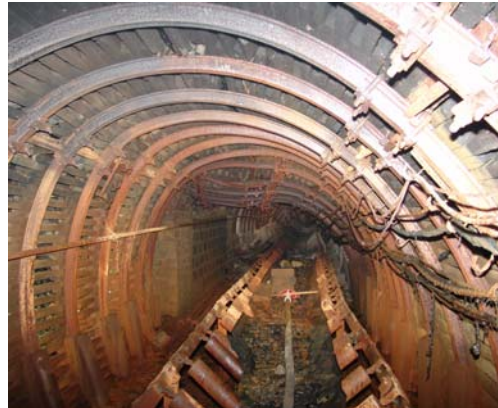
Figure 7: Misshapen support in U-24

As a result of the fire, the timber poling of the LP support in drift U-24 was burnt up to a length of 405 m and in drift U-25, 150 m. Drift U-24 suffered collapse at two sections, lengths of 70 m and 45 m with caving to heights from approximately 1.5 m to 2.5 m and also at three intersections to heights of between 2-3m. Infrastructure suffering fire and/or heat damage included the belt of the conveyor in U-24 (within

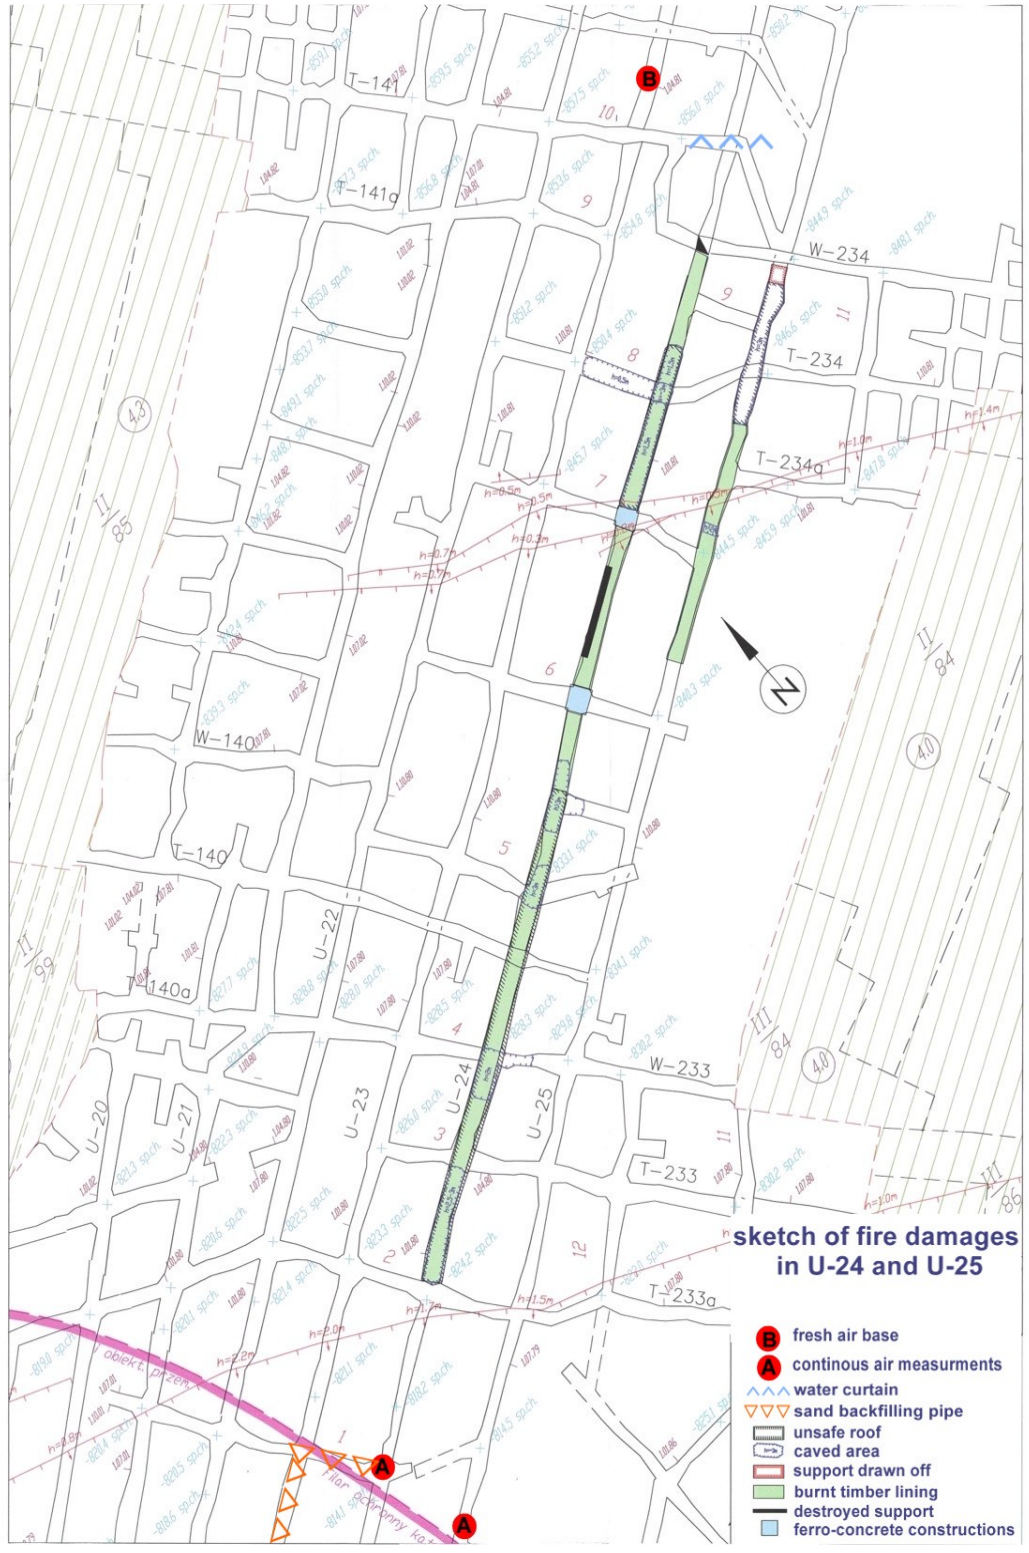
Figure 8: Sketch of fire damages

the section that was exposed to fire) and energy and telecommunications cables. Within drift U-25, roof rock structure collapsed to a height of approximately 3 m within a 60 m section.

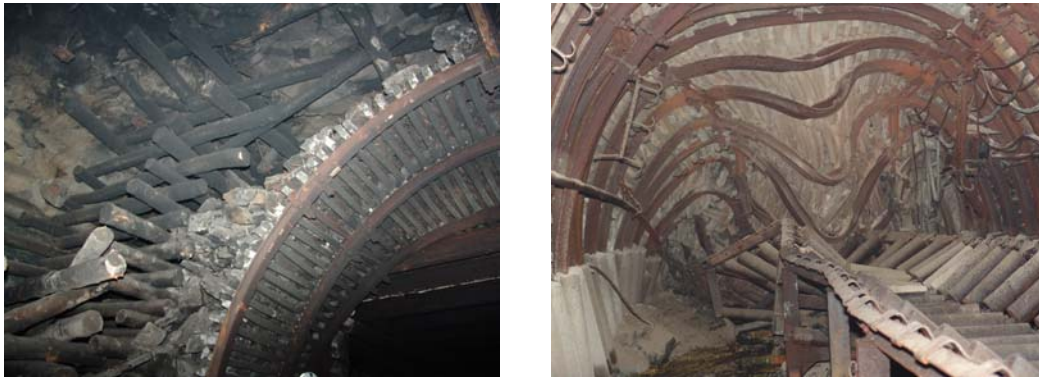
Figure 9: Timbers beyond poling of support Figure 10: Caving in U-24
