***Methane ignition, methane  
and coal dust explosion  
and accident with multiple casualties  
on 21 November 2006  
in Halemba Coal Mine  
(Ruda Śląska, Poland)***

Piotr Buchwald, President of the State Mining Authority

**On 21 November 2006 at 4.30 p.m. methane ignition and explosion took place at the 1030 m level in the area of longwall 1 (coal bed 506, batch E) in Halemba Coal Mine.**

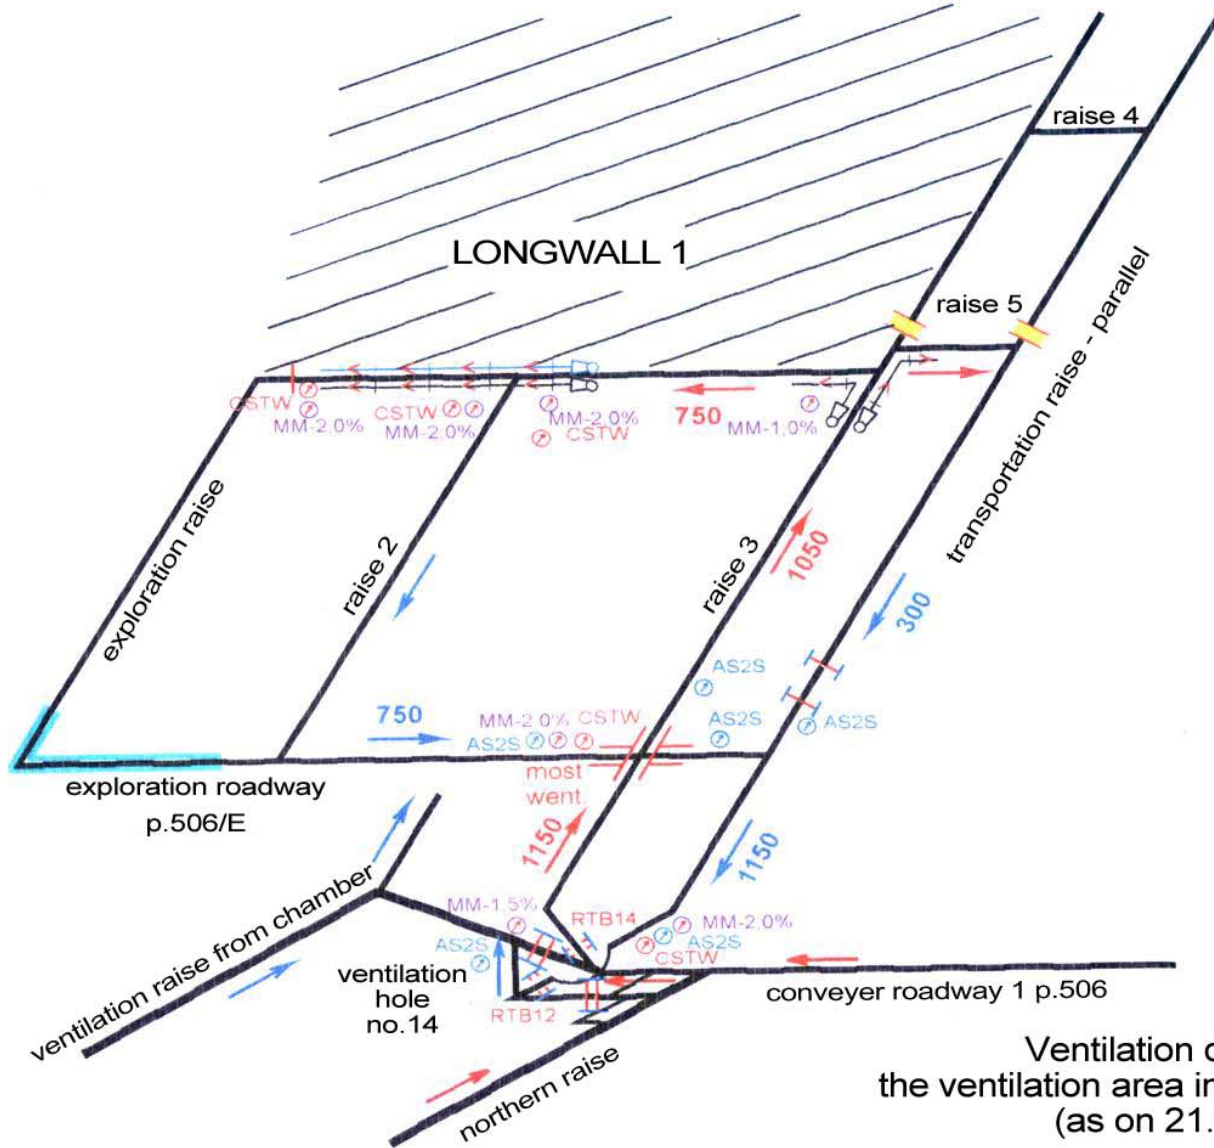
Ventilation diagram for  
the ventilation area in the coal bed 506/E  
(as on 21.11.2007)

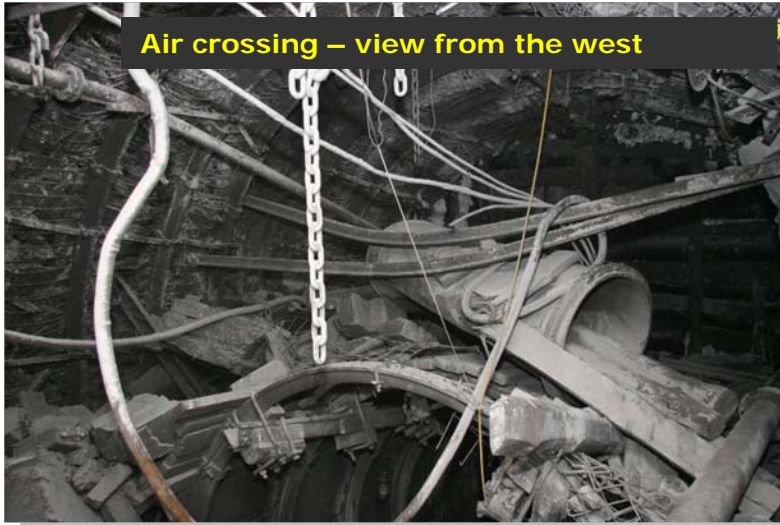
Air crossing – view from the west

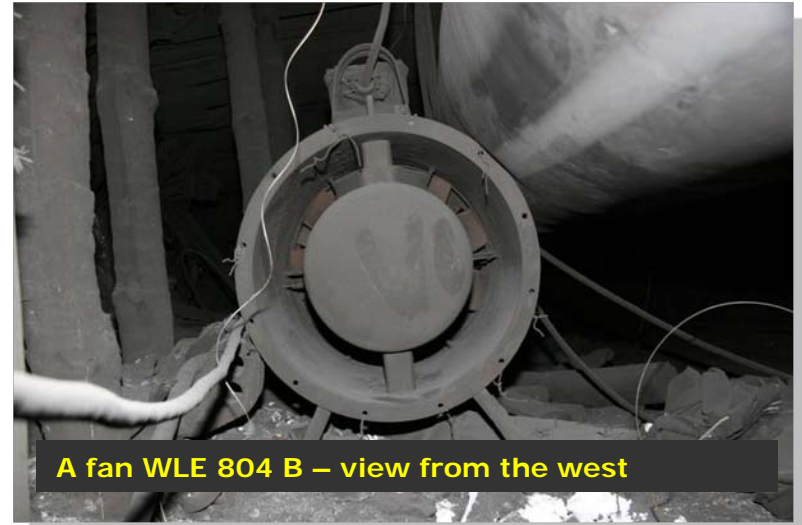
A fan WLE 804 B – view from the west

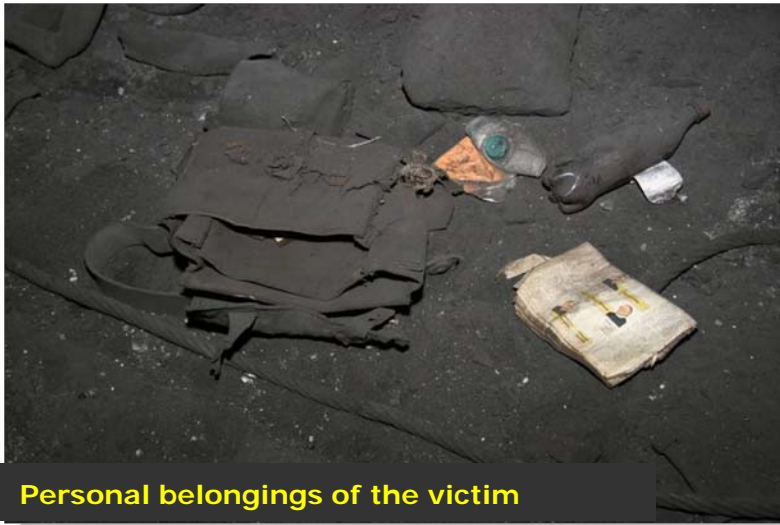
Personal belongings of the victim

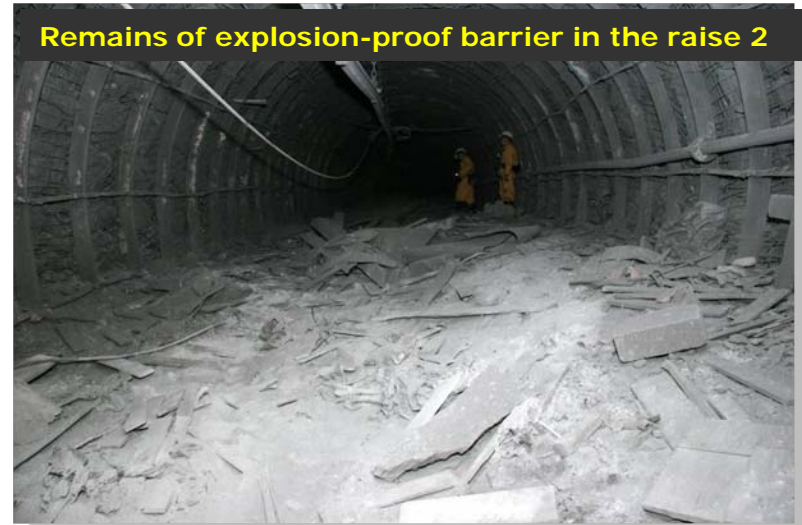
Remains of explosion-proof barrier in the raise 2

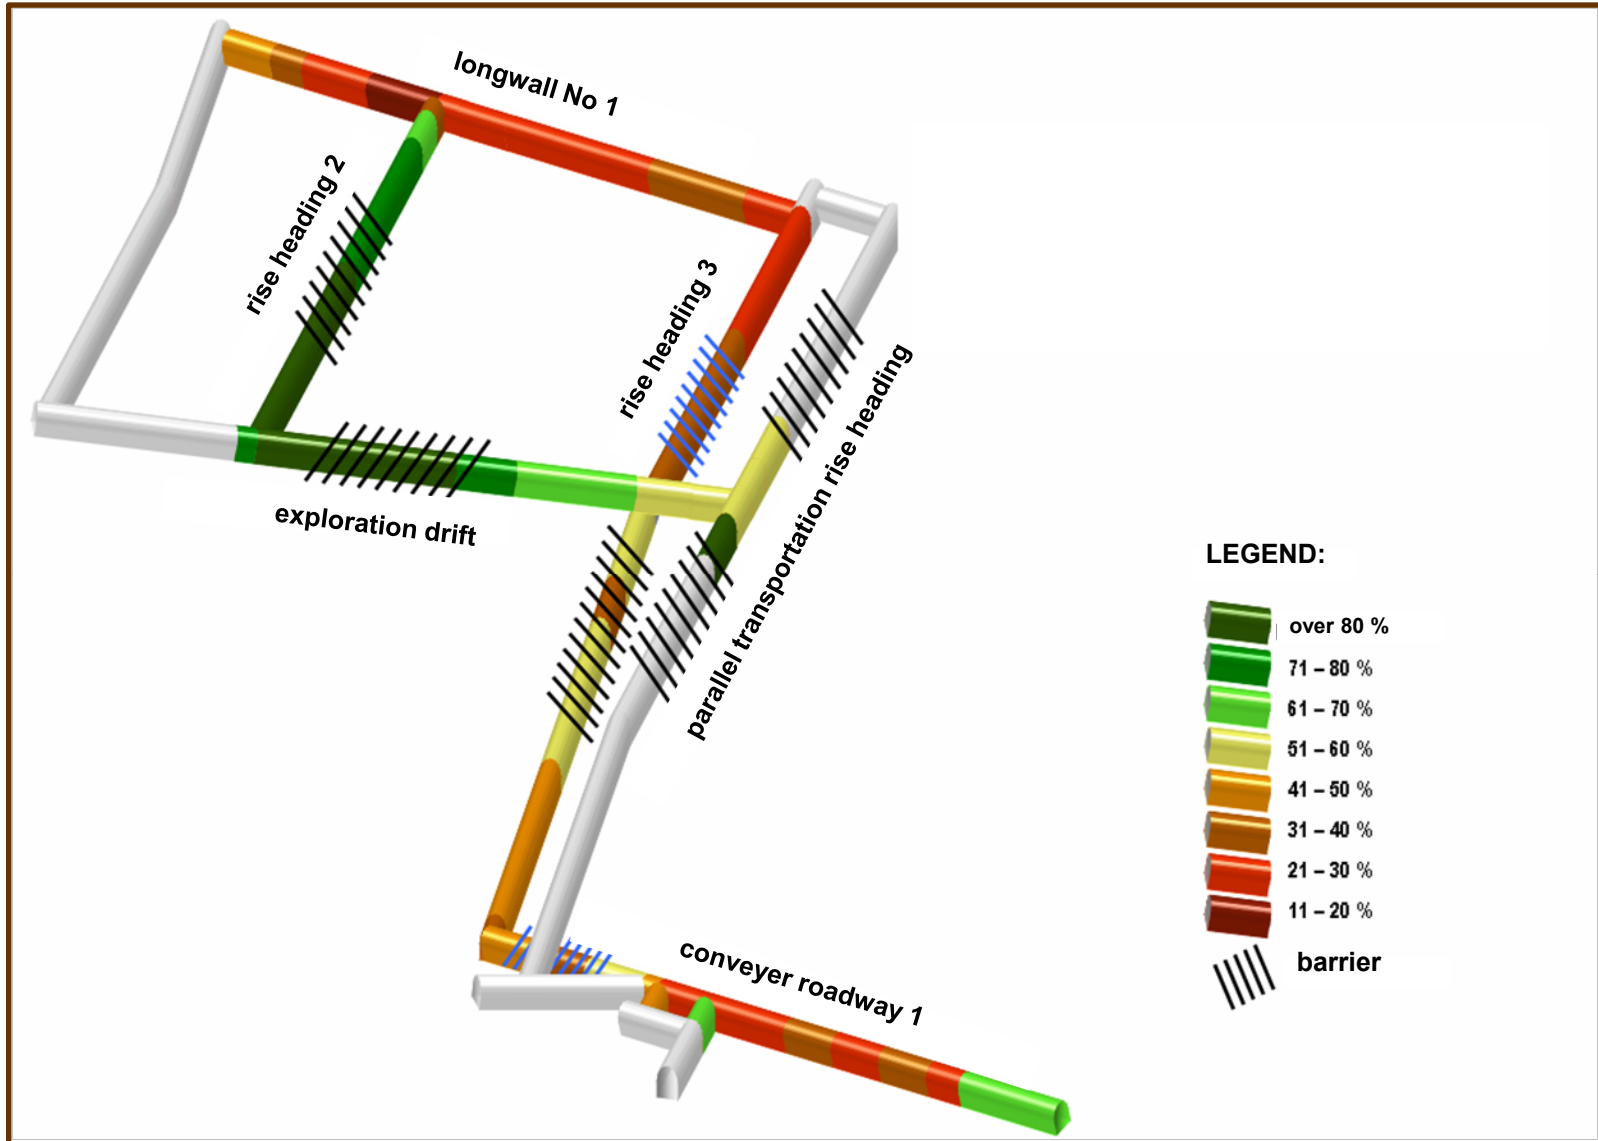
# The content of incombustible matters in mine dust

**Coal dust explosion and its spreading resulted from breach of regulations on coal dust explosion control.**

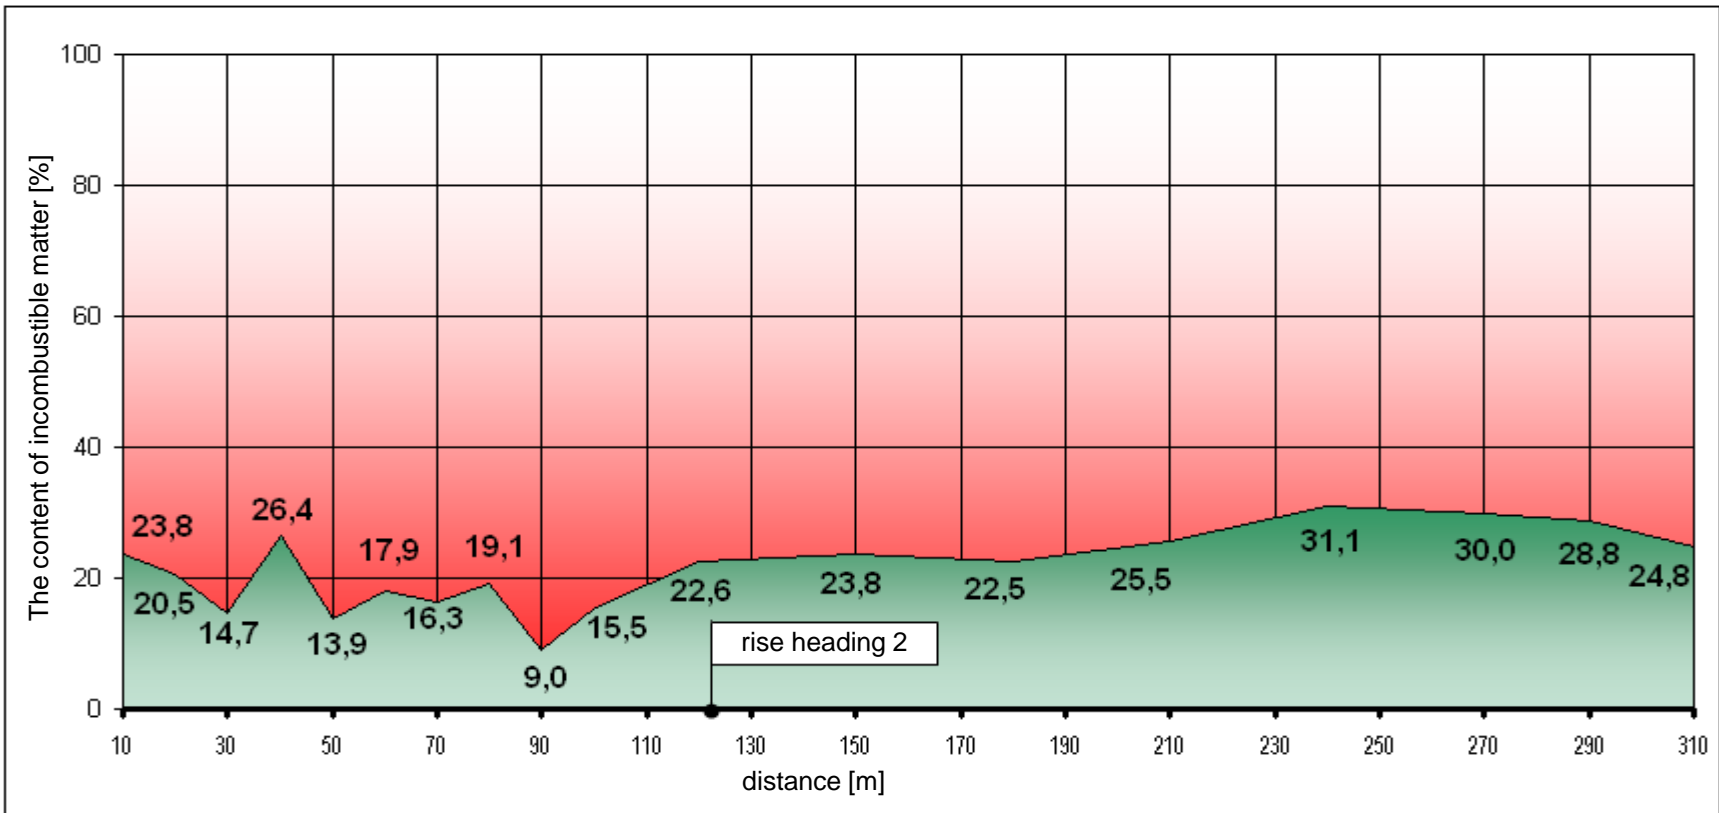
## Longwall No 1 seam 506

# The content of incombustible matters in mine dust

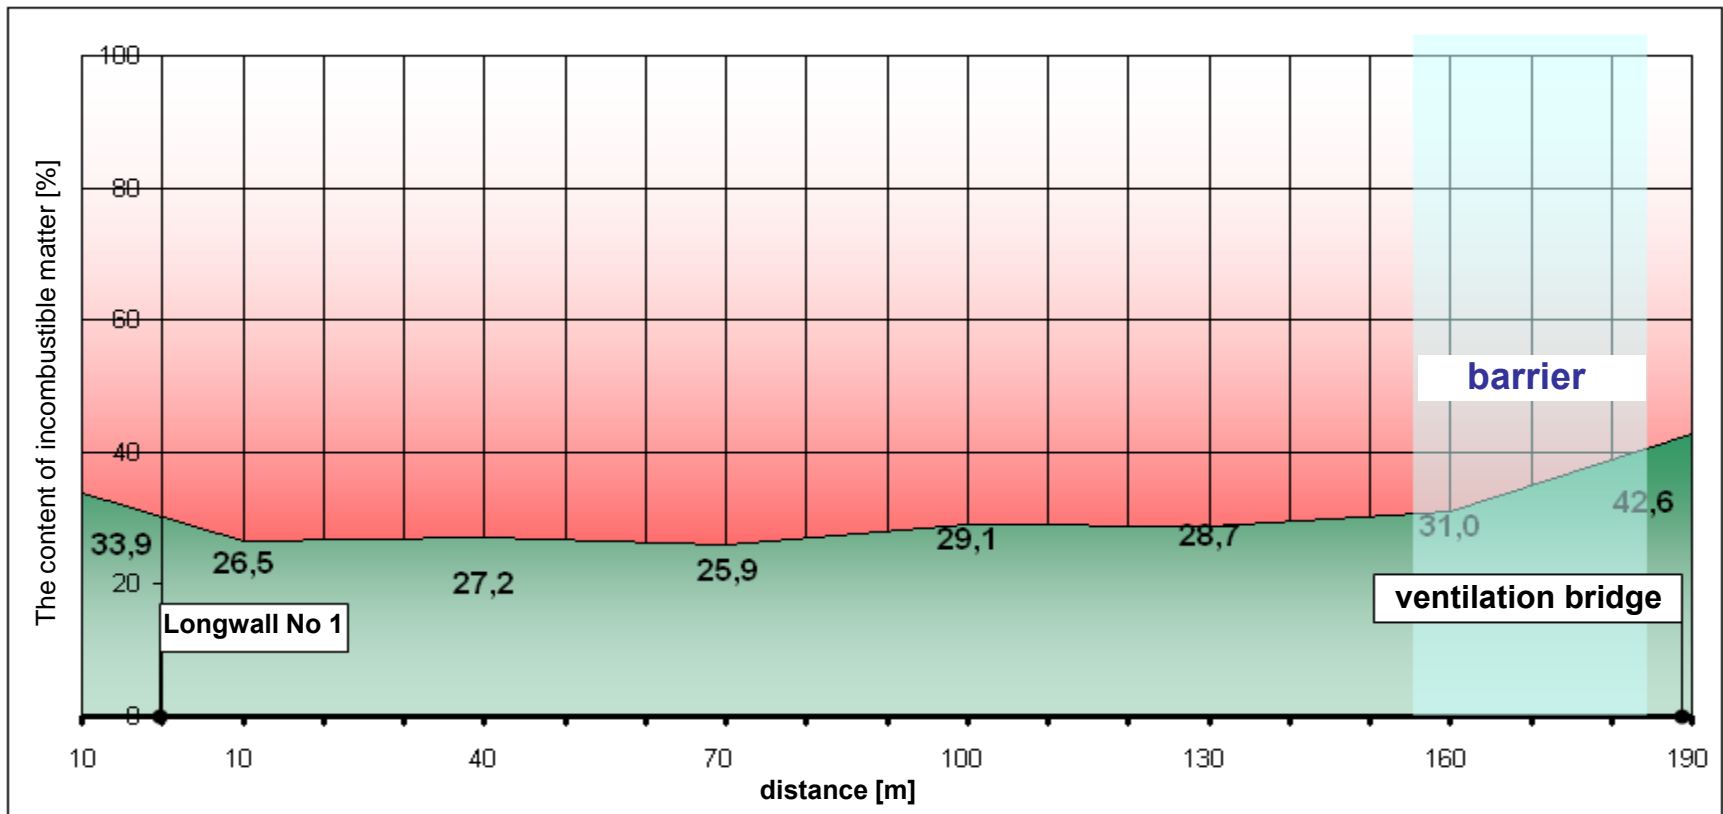
## rise heading 3

# The content of incombustible matters in mine dust

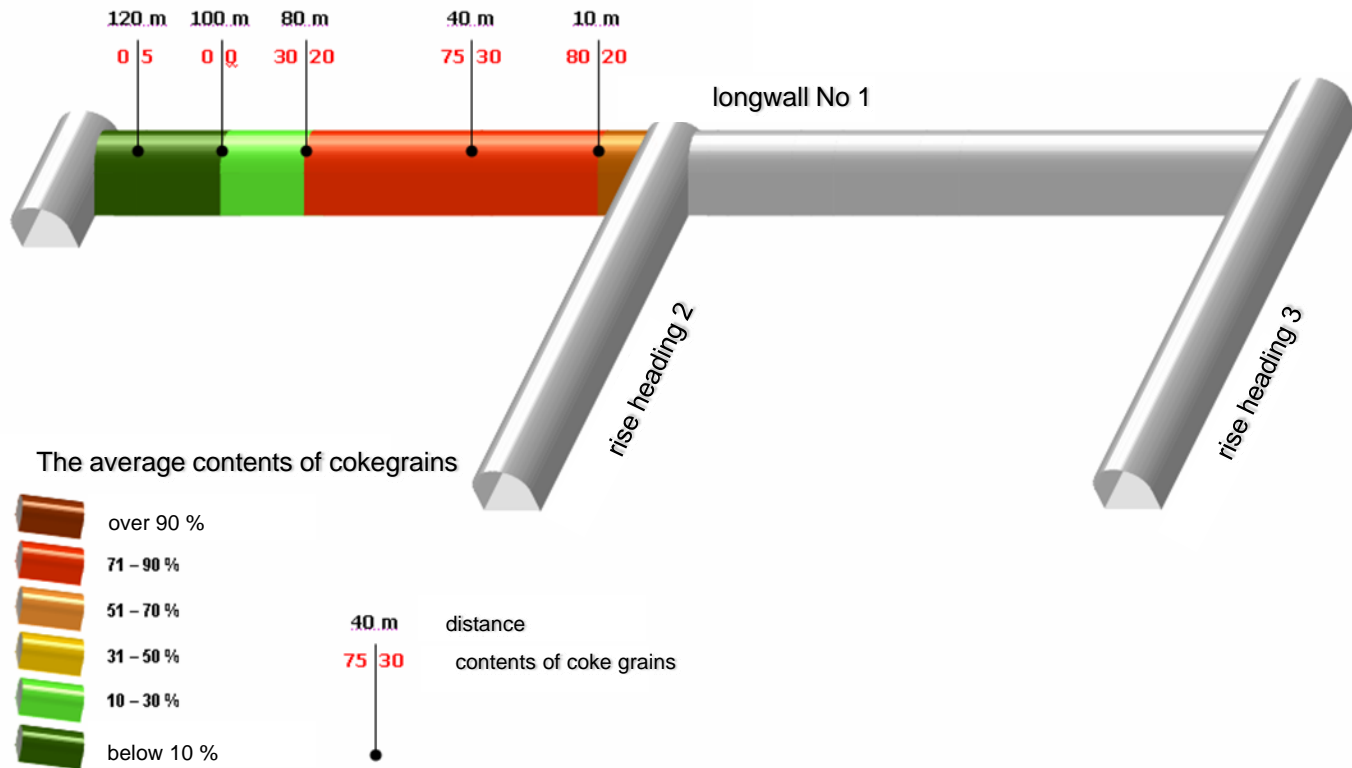
# Determination of the place of ignition of explosion

Determination of the place of ignition of explosion  
in the area of longwall 1 „HALEMBA” MINE
