**Experiences from exogenous  
fire incident rescue  
operations at 1C coal-seams -  
Trangbach East area of  
Dongvong Coal Mine  
Company in Vietnam**

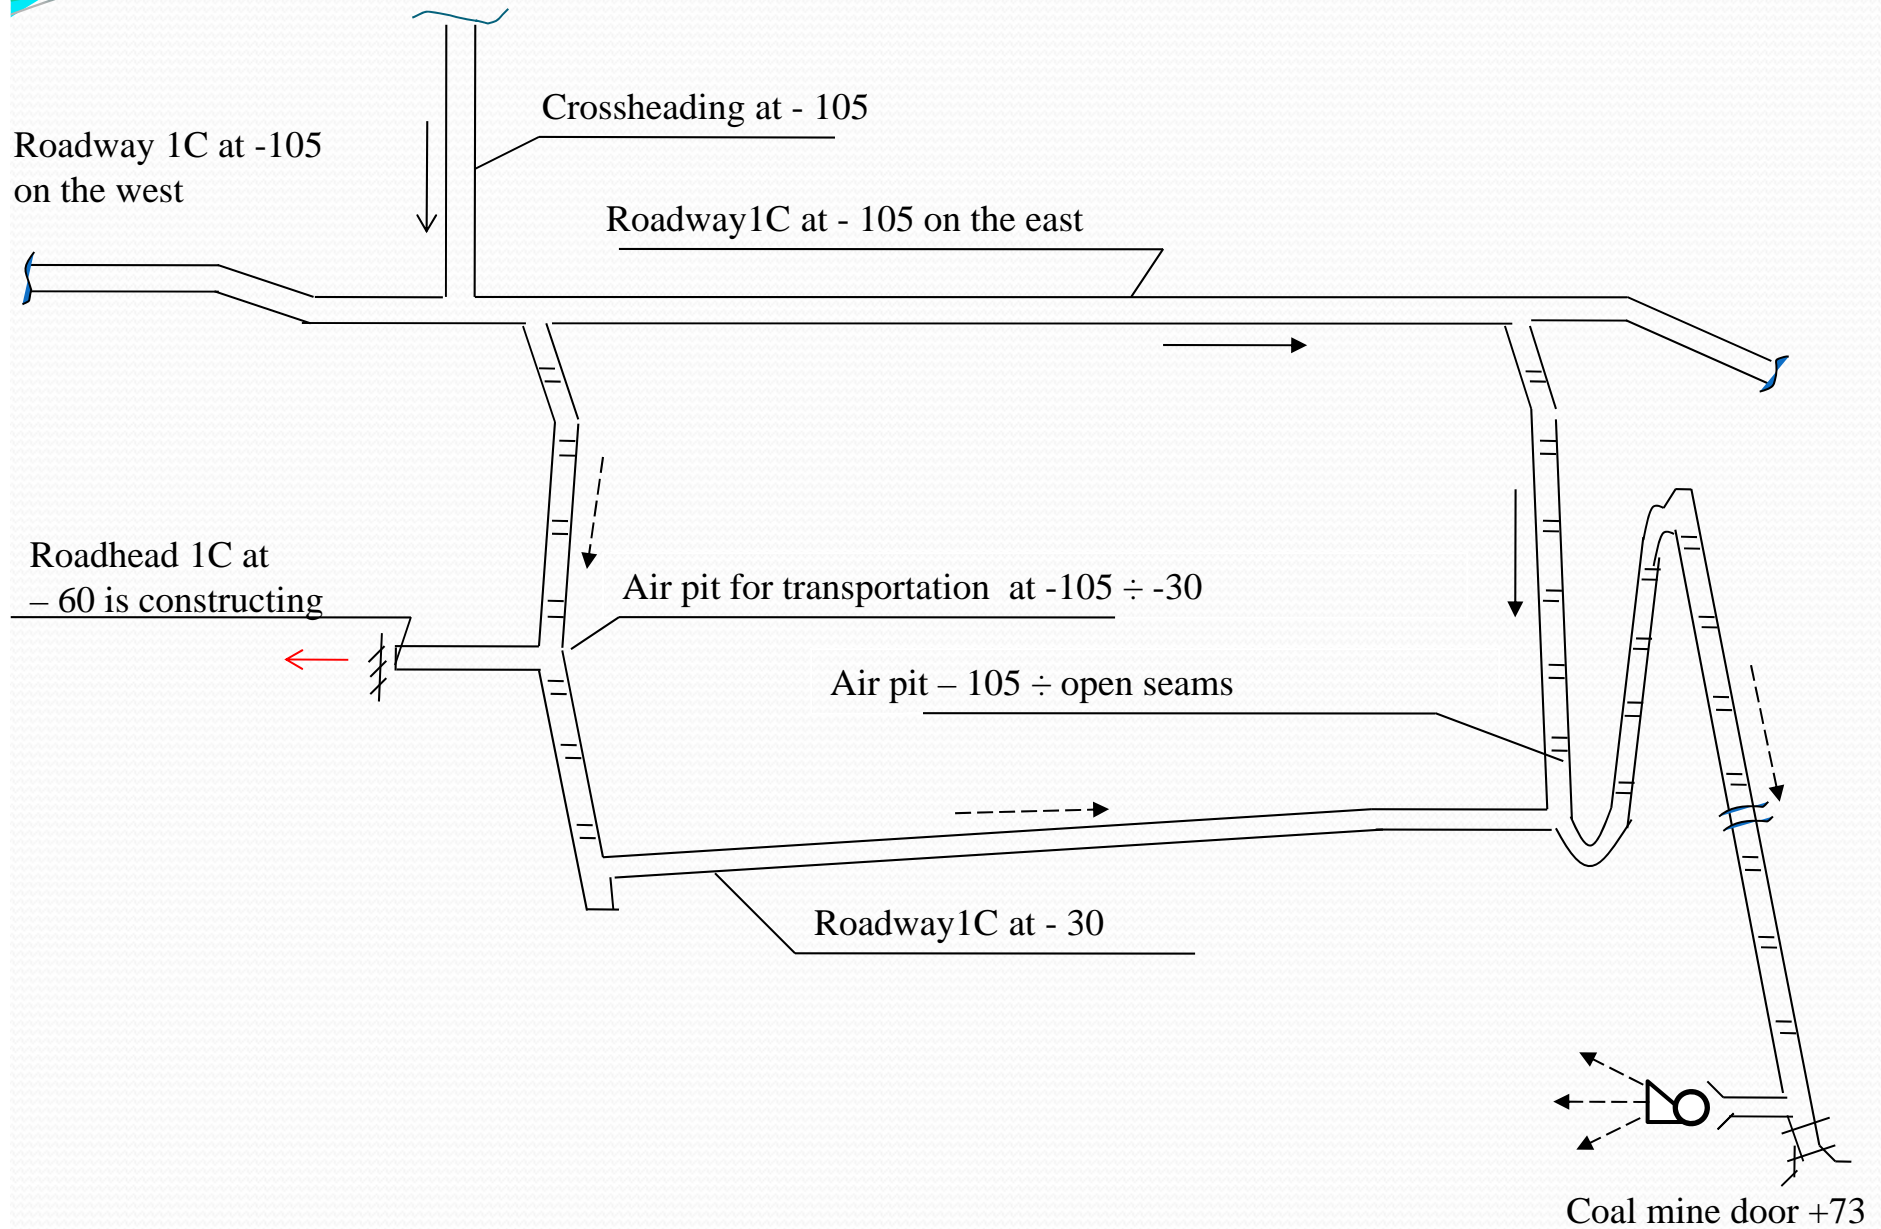
# Map of incident area

*East Trang Bach 1C coal-seam has been put into operation in Dong Vong Coal Mine Company since 2007. From the position (sea-level)  $\pm 0$  and above, coals have been fully exploited. Up to January 2014, the company has cleared to the level - 105 and has been zoning an area for exploitation from lever -105 to -30. The protection pillar for exploited floor is 30 height.*

*At the time of Jan 15<sup>th</sup> 2014, the company has been digging the stratified face at the level -60 in order to divide working face to two stratified faces.*

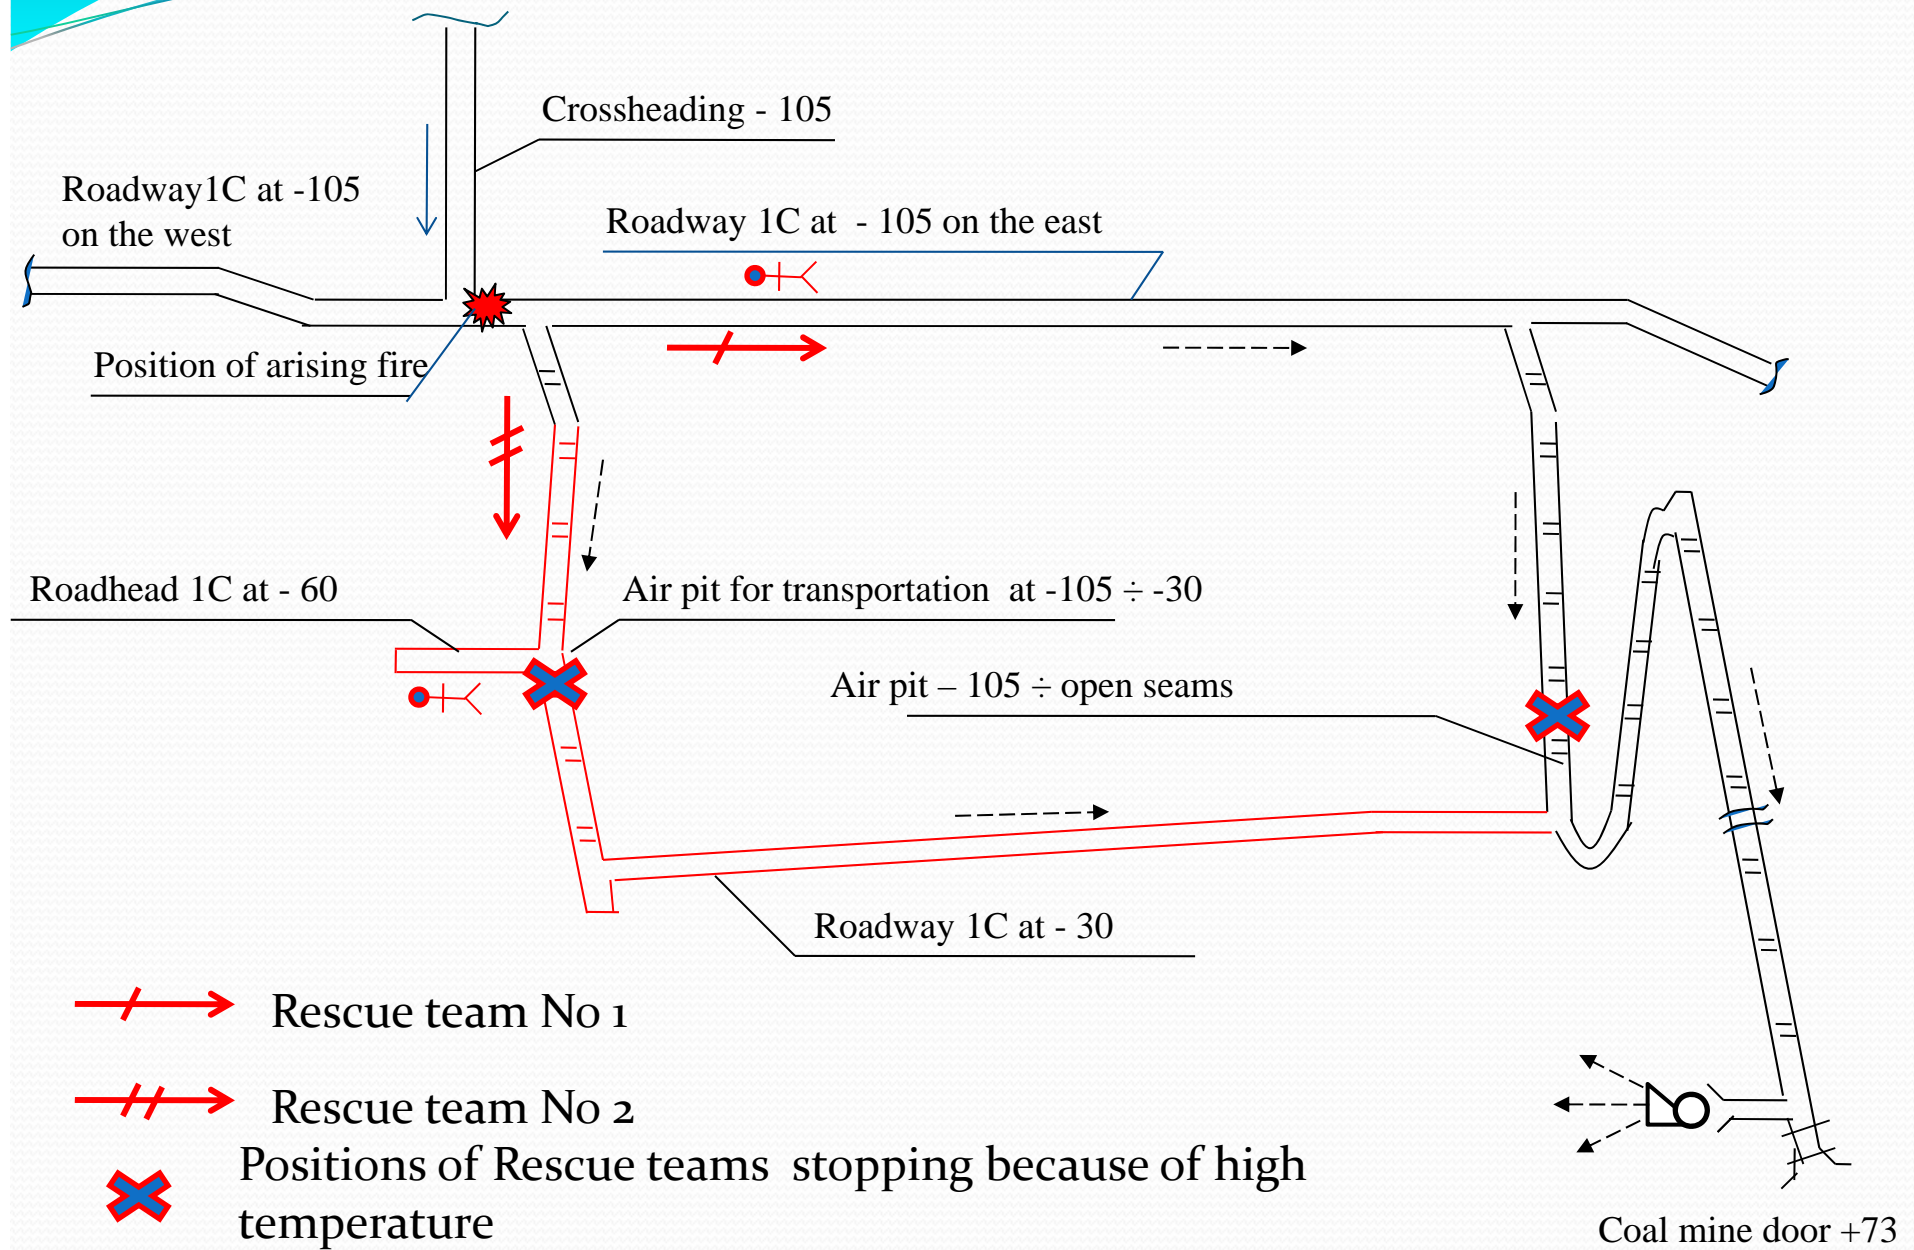
# Map of fire area and examination direction

*At the beginning of the third shift on Jan 15<sup>th</sup> 2014, a group of 6 workers and a leader of the group were entering into working mine with the opposite direction of exhaust air flow through ventilation door +73. When coming to the level -30 having much of smoke, the leader of group had telephoned to deputy shift manager about much of smoke in the tunnel.*

*Deputy shift manager asked them to go out but the leader still entered. Coming to roadhead -60, he couldn't go. He used filter self-rescuer POG 8 but not alive. Rescue team of VMR found him at this position at 2:30 am Jan 16<sup>th</sup> 2014.*

*When having much of smoke, two workers were actively running along the air pit down -105 but there still were much of smoke. One worker alived and the other died at the roadway level -105 on the east, from three-way crossheading about 50 meters. Rescue team of VMR found him at 2:00 am Jan 16<sup>th</sup> 2014.*

*The fire was determined from the heading of conveyor at level -105, fire along the conveyor to the wood and scrap conveyor of the air pit bulkhead -105 -:- -30. Due to the heat of the fire to very high temperature airflow from the exhaust fan located at the door +73 so fire quickly spread to the air pit -105 -:- -30 and the whole roadway +30.*

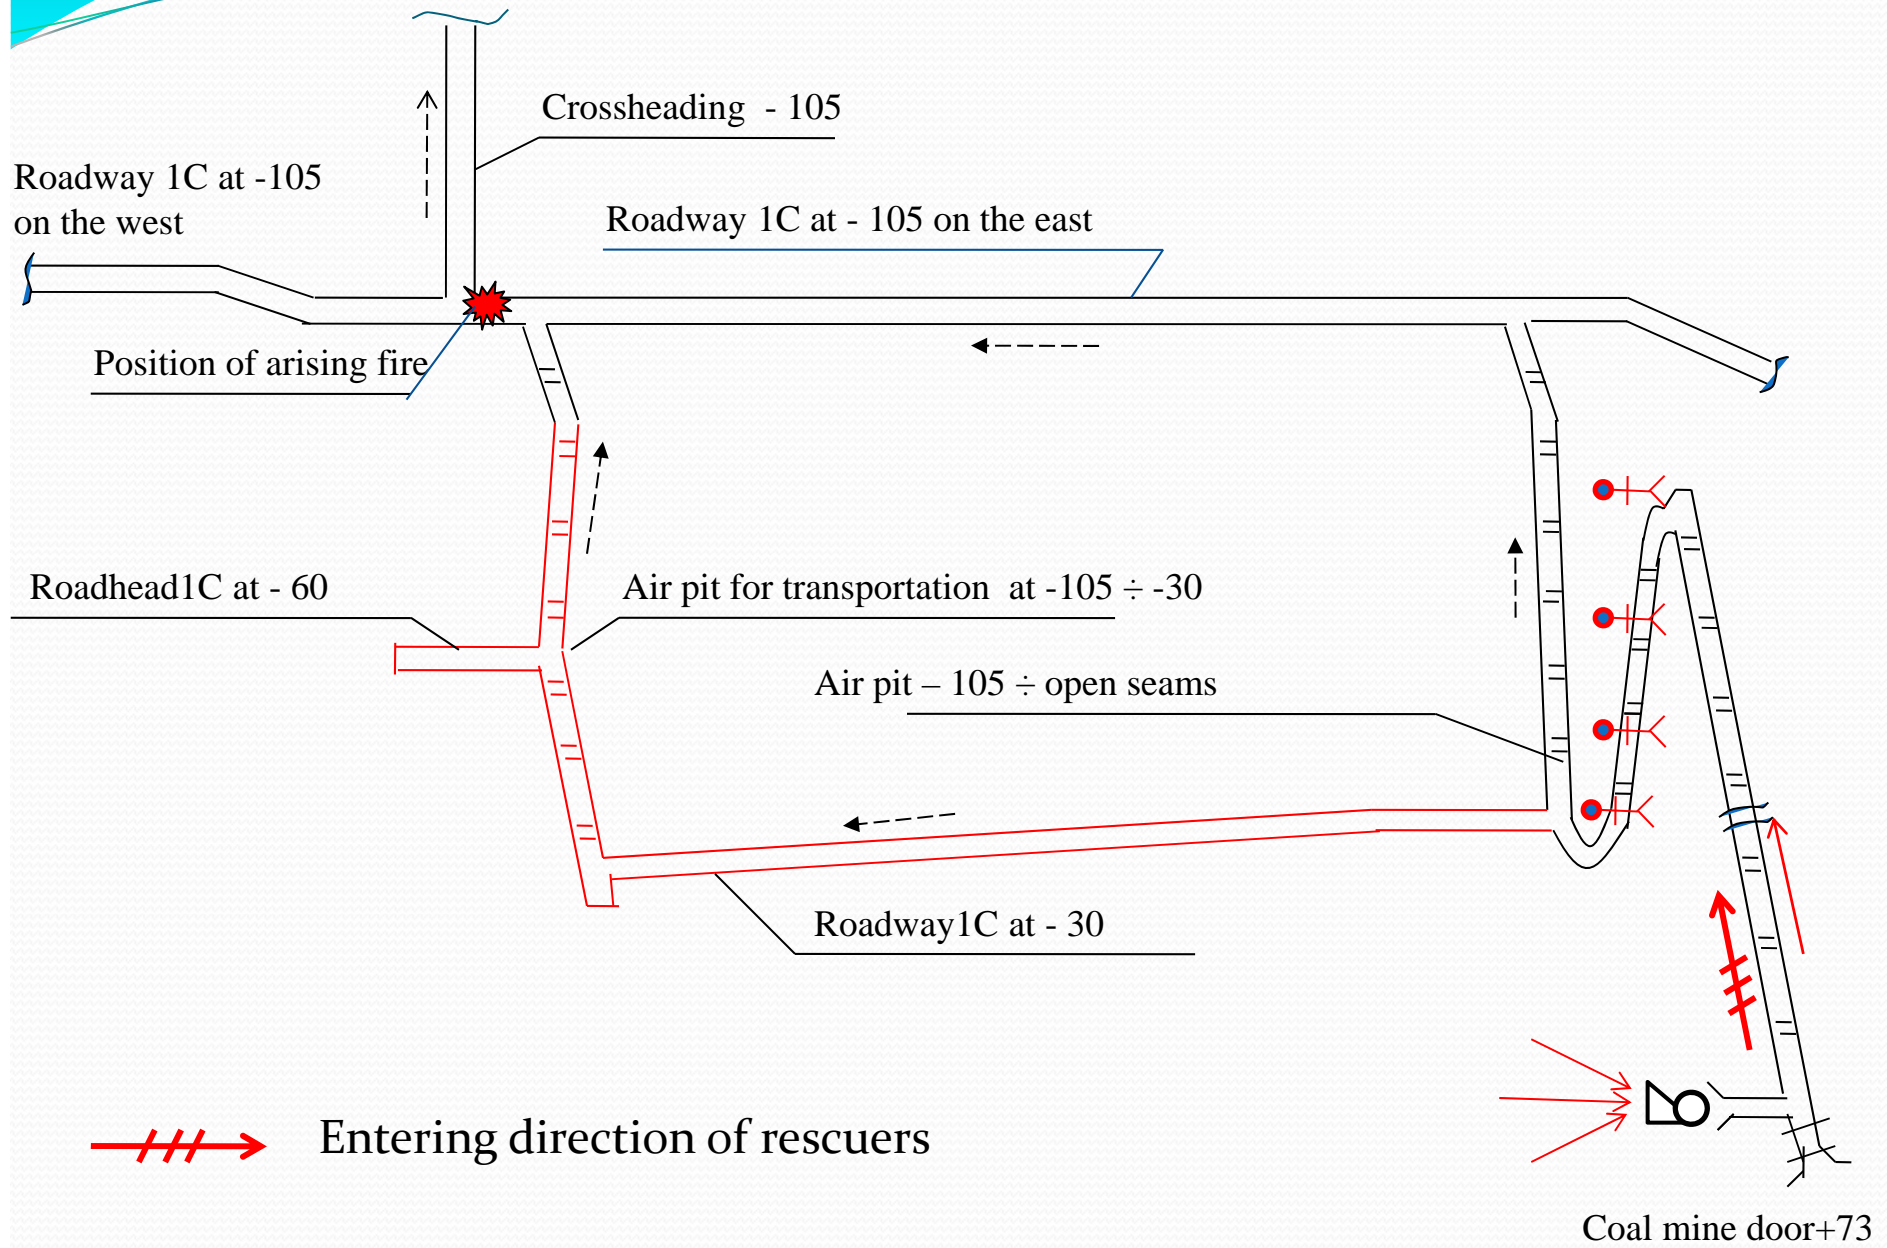
# Map of reversal airflow direction and victims' position

*There were not four found victims. In the prediction, they were may be in the roadway level -30, but due to too high temperature could not be approached. Rescue body basing on the company's database and the deputy shift manager's report had determined to reversal airflow direction. At the time 4:30 am, the main fan at the door +73 was working as exhausting mode to be changed as flushing mode to push clean air to approach the roadway level -30.*

*All of 4 engines of 2 fans operated and after 1 hour smoke was pushed pressed down 60 metres. After 2 hours rescuers reached the 4 victims.*
