## 2<sup>nd</sup> International Mines Rescue Conference 2005

### Emerging Mine Inertisation Philosophy carried out in the United States of America

***Ian Houlison,  
Dave Hussey,  
George Watson,  
Patti L. Meyer,***

### **Glassport, Pennsylvania USA**

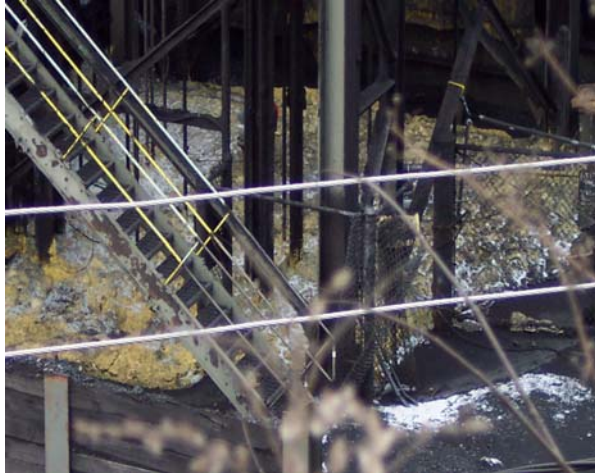
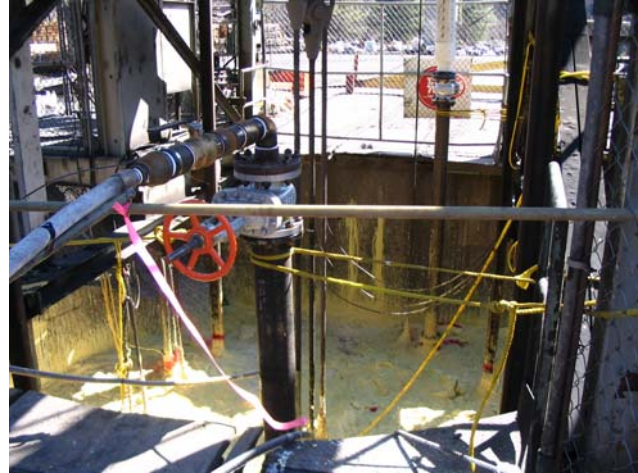
The seals were fabricated with timber, brattice cloth and commercially available light foam packs with an underlying steel bracing.

This proved to have a limited effect due to the expansion of gases underground which led the incident management team contacting MICON to install a much more durable material to these sites.

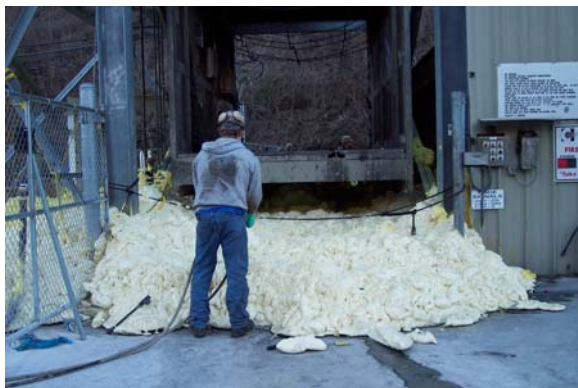
**Technician preparing to re-seal site**

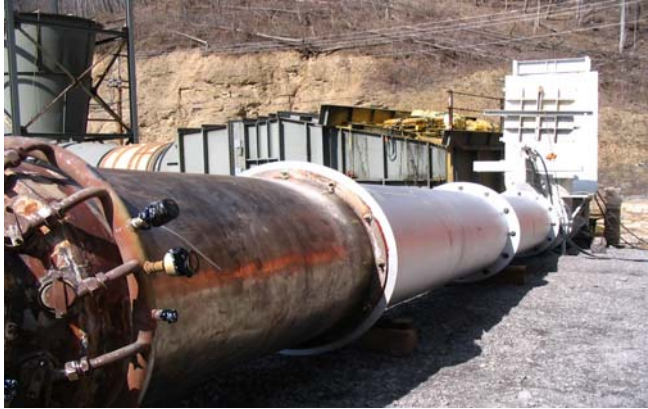
**Tubes connected at No. 9 Shaft**

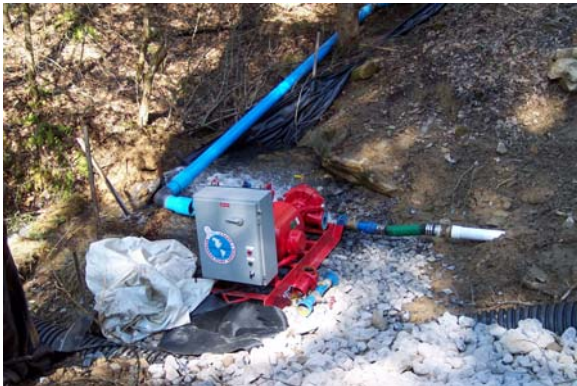
**Water Supply Pump from Dam  
Blue Pipe is line to tanks**

The main water supply from the dam that was purpose built needs connection to the feed pump and then connection to the supply pipe to raise the water 360 vertical linear feet to the holding tanks.

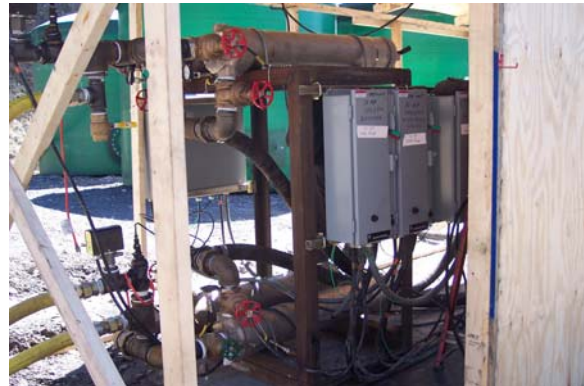
**Water re-circulation filters with  
holding tanks in the background**

Still left to be done are the connection of the water supplies to the re-circulation tanks and the hydraulic pump to the control station then to the slide gate.
