“Technical and legal aspects for rescue operation performed in harsh climate condition in Polish copper mines”

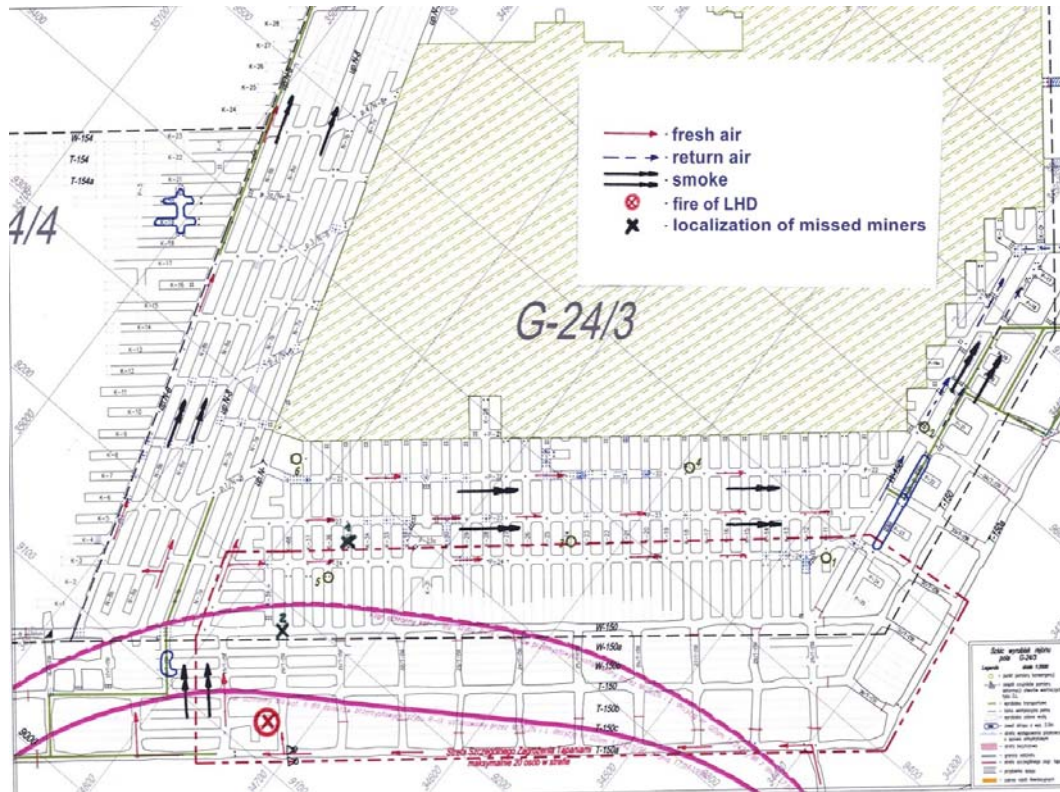
Figure 2: Map's sketch – localization of fire and missed miners

Due to their inability to put out the blaze, the rapid spread of fire and intensifying smoke, the operators retreated from gallery T-150b to the intersection with cross-cut P-19. Due to intense smoke situation at this point the operator of loader No 187 wearied a breathing apparatus and retreated in the direction of gallery T-150a, which was the fresh air inlet for the precinct G-24/3, however in the dense smoke he lost his orientation and he get lost. The other two operators managed to retreat to the local conveyor bin feeder at gallery W-150. From here at 10.54 they raised the fire alarm calling to the mine dispatcher.

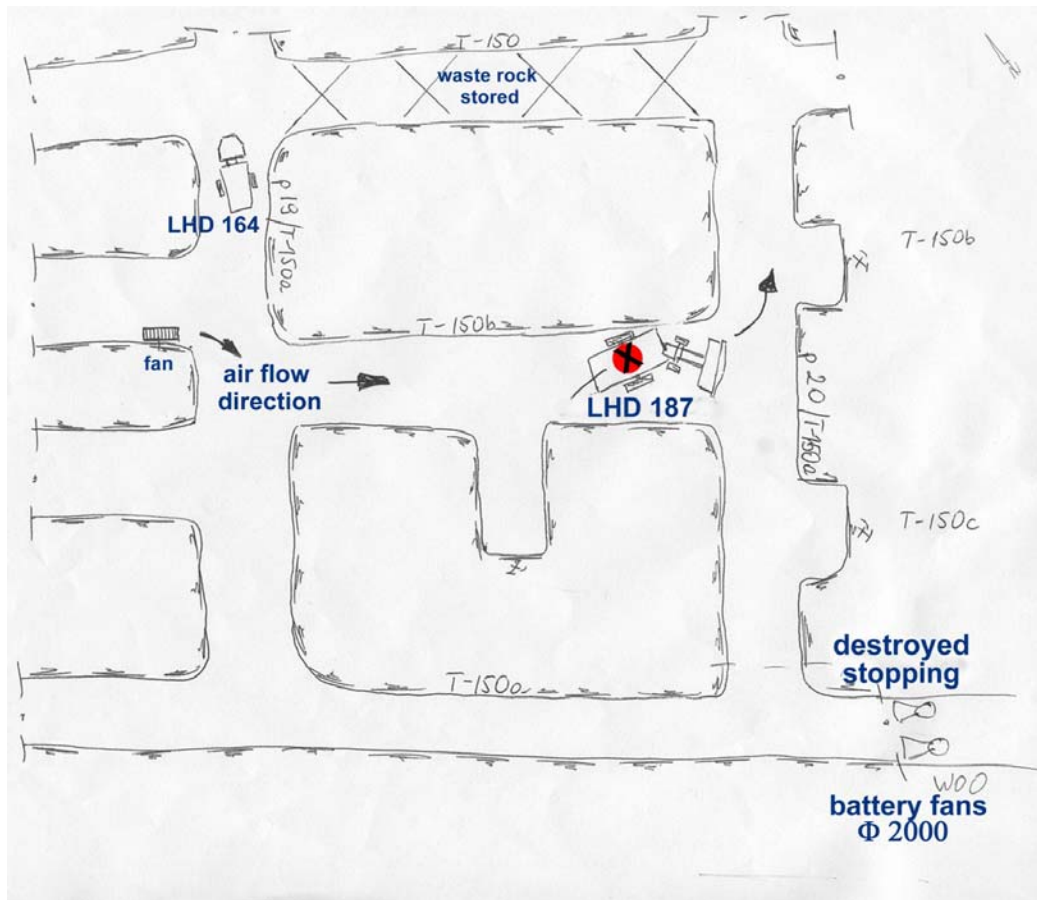
Figure 3: Sketch of workings in area of fire.

At 11.13 (19 minutes after receiving notification of the fire) the operation staff determined that there were 82 workers within the potentially threatened area (this included workers from neighbouring sections). After an hour counting all miners whose have left the endangered area it was stated that there were two workers missed. One of them was mentioned driver of LHD loader and another one was foreman who also gets lost in smoke when he tried to gather miners from all crews for evacuation.
